FULL-SCALE DYNAMIC CRASH TEST  
OF A  
LOCKHEED CONSTELLATION MODEL 1649 AIRCRAFT

TECHNICAL REPORT  
ADS - 38

October 1965

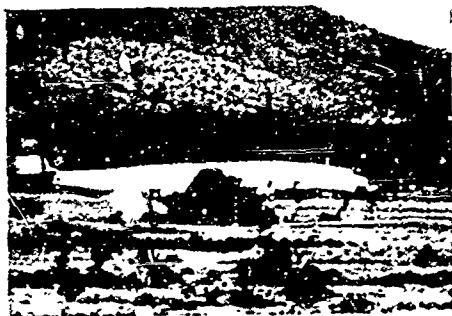
The nose of the airplane contacted the ground at the foot of the 6 degree slope and slid into the hill, as shown in pictures D, E, and F, Figures 19 and 20. No major breakup of fuselage structure occurred during this impact.

Fig. 19 Right Side View of Crash Sequence. (Time correlated with data presented in Appendix VI.)

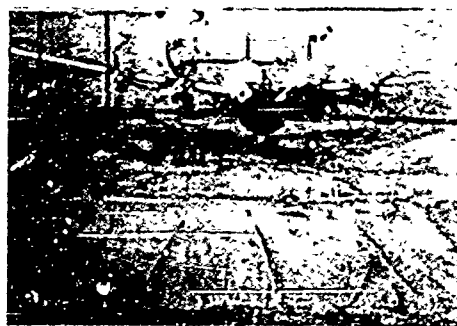
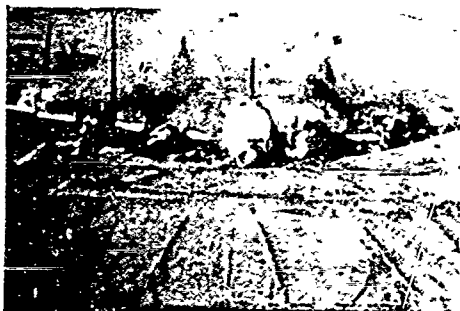
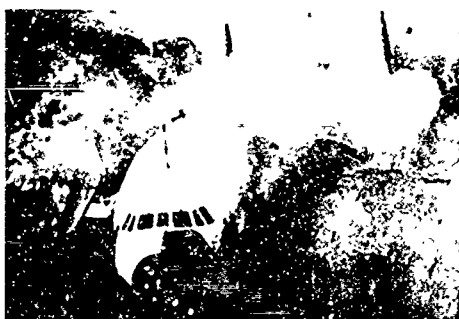
Fig. 20 Head-on View of Crash Sequence. (Time correlated with data presented in Appendix VI.)

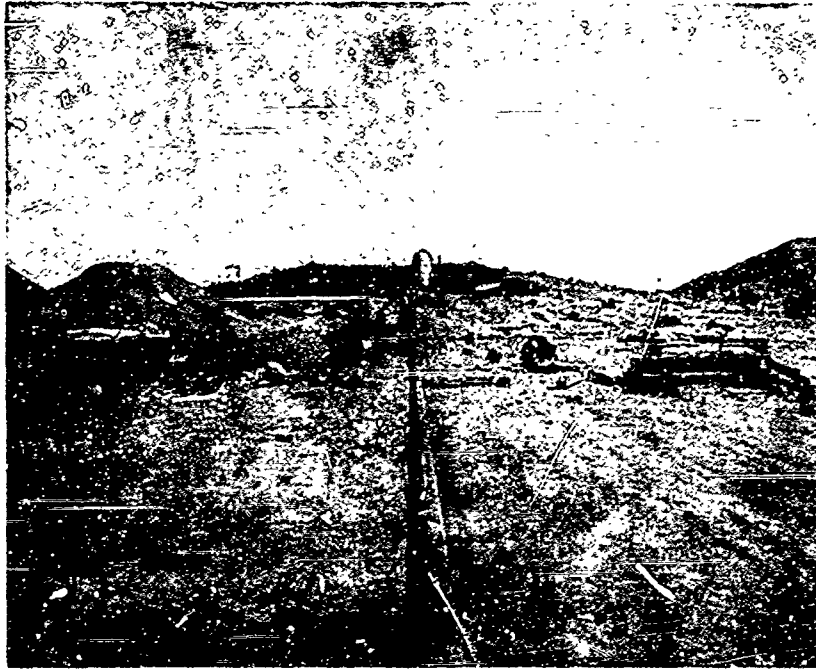
Figures 21 through 27 show how the aircraft broke up as it progressed through the crash barriers leaving a trail of small parts, pole splinters, and spilled liquids (engine oil and simulated fuel). Except for the engines, main landing gear and the right vertical stabilizer, the major parts of the aircraft came to rest on the second impact slope in a small area with the fuselage nearly aligned with the original path from the guide rail.

FIG. 21 POSTCRASH POSITION OF FUSELAGE IN RELATION  
TO ALIGNMENT WITH GUIDE RAIL

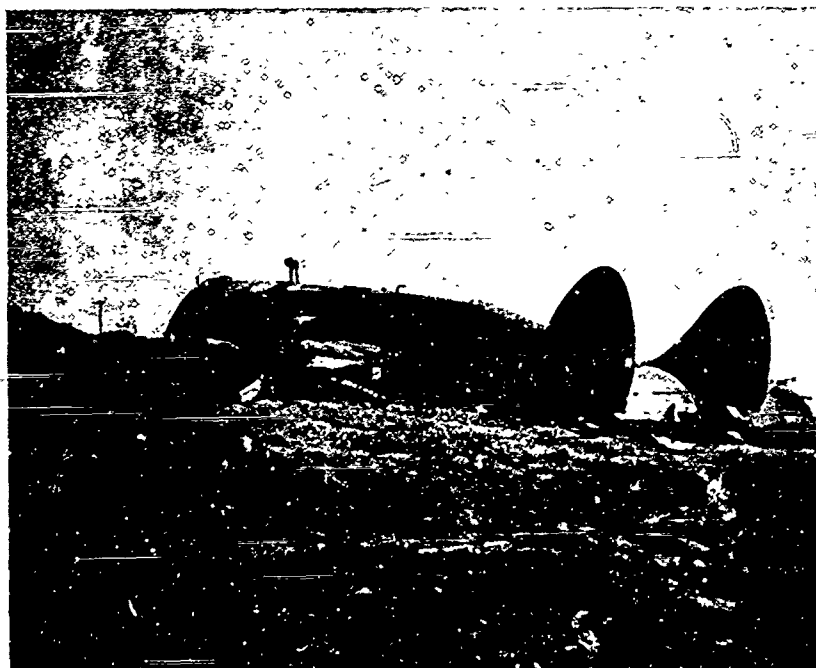
FIG. 24 LEFT SIDE VIEW OF WRECKAGE

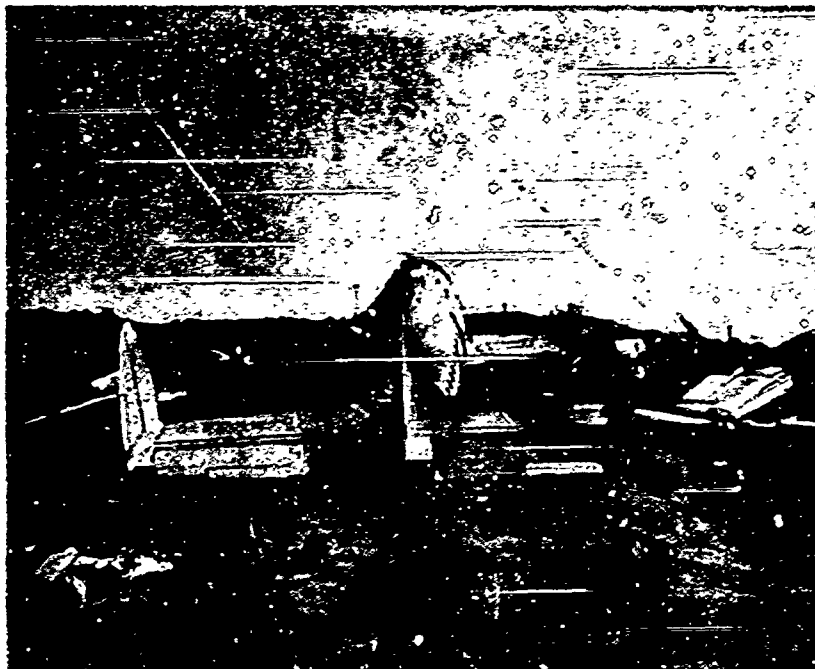
FIG. 25 REAR VIEW OF WRECKAGE

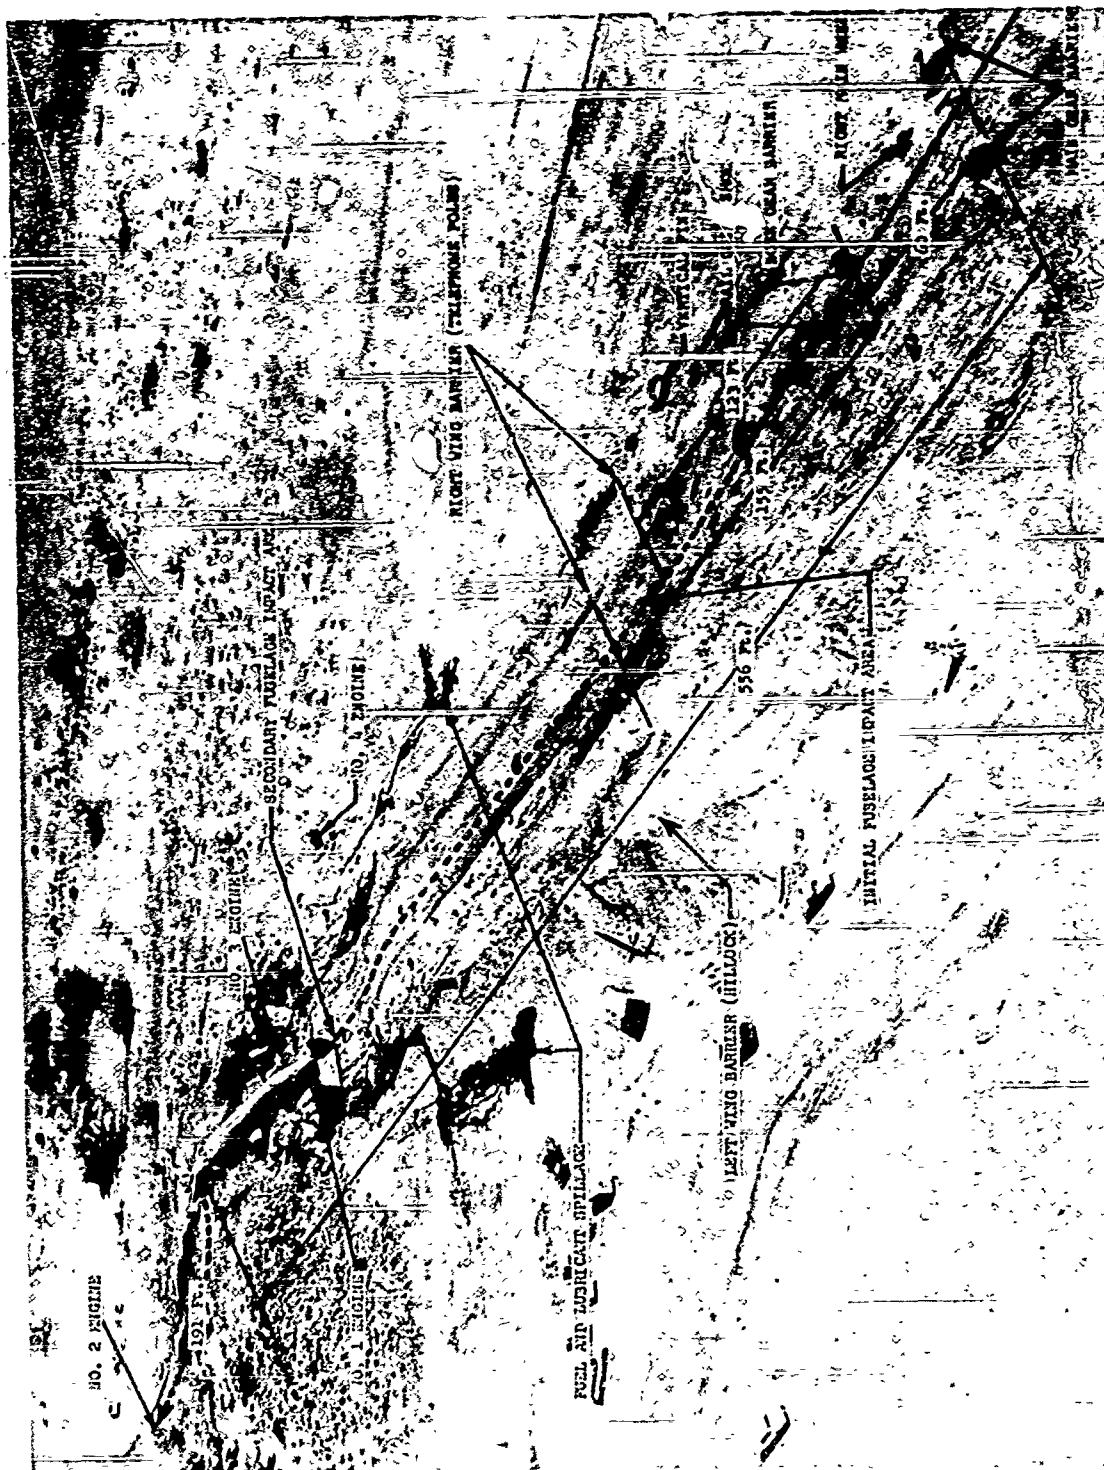
FIG. 27 WRECKAGE DISTRIBUTION PATTERN

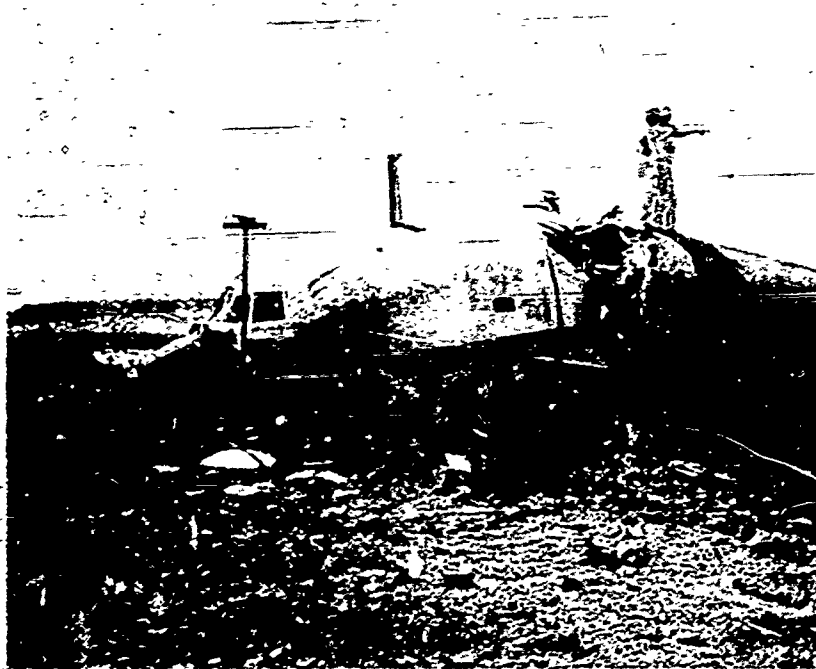
FIG. 29 FORWARD FUSELAGE AND COCKPIT STRUCTURAL  
DEFORMATION, RIGHT SIDE

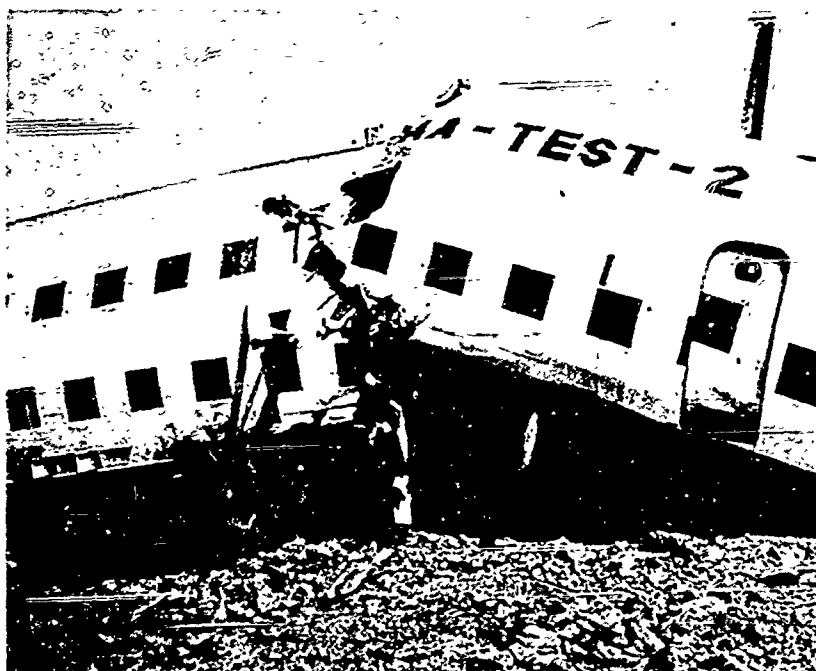
FIG. 30 FORWARD FUSELAGE AND COCKPIT STRUCTURAL DEFORMATION, LEFT SIDE

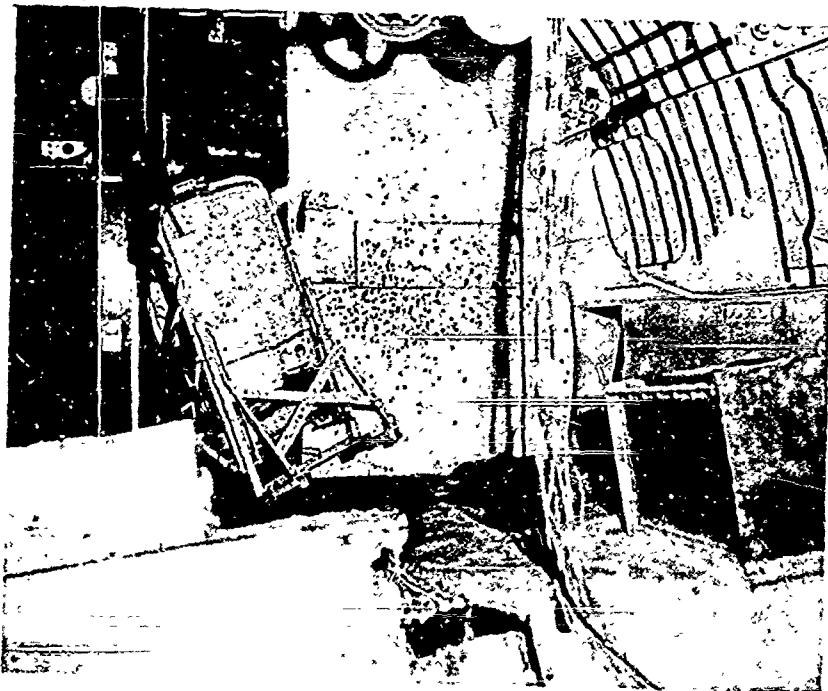
FIG. 58 POSITION OF  
COPILOT  
DUMMY,  
POSTCRASH

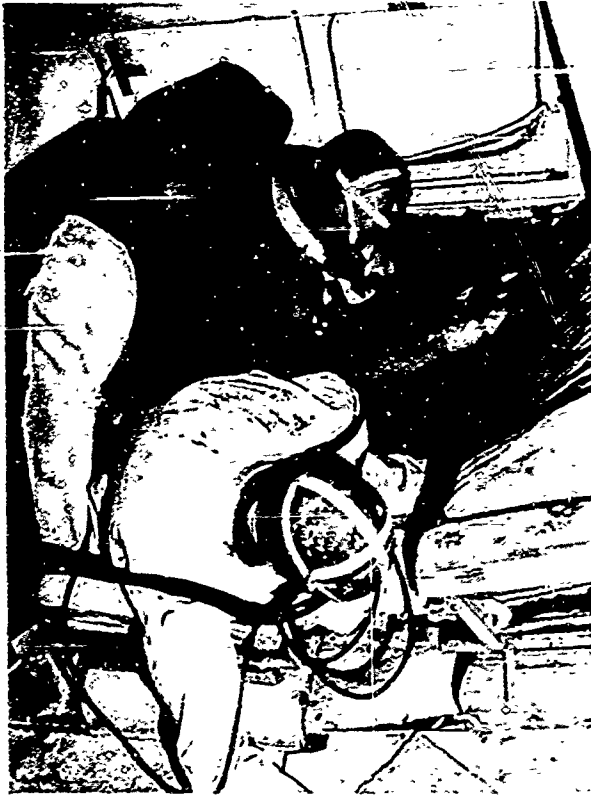
The center seat experienced no lateral deterioration. Vertical loading caused slight downward bending of both front and aft lateral seat frame tubes. Figures 67 and 68 show the seat and occupants. The armrest supports failed allowing the armrest to rotate toward the aisle approximately 30 degrees. Both lap belts remained intact and fastened. The dummy seated next to the wall was still in place with feet and legs approximately in the normal riding position. The dummy was bent forward so that his chest was resting against his thighs and his head had contacted the seat back of the forward outboard seat. The dummy seated next to the aisle remained in the seat, bent forward, with head out in the aisle. Both legs of this dummy were extended under the forward seat, up to the knee for the left leg and halfway to the knee for the right leg. Examination of the forward inboard seat back indicates that contact between the inboard dummy and the seat back was very slight.

FIG. 67 POSTCRASH VIEW OF CENTER CONSTELLATION  
SEATS AND OCCUPANTS

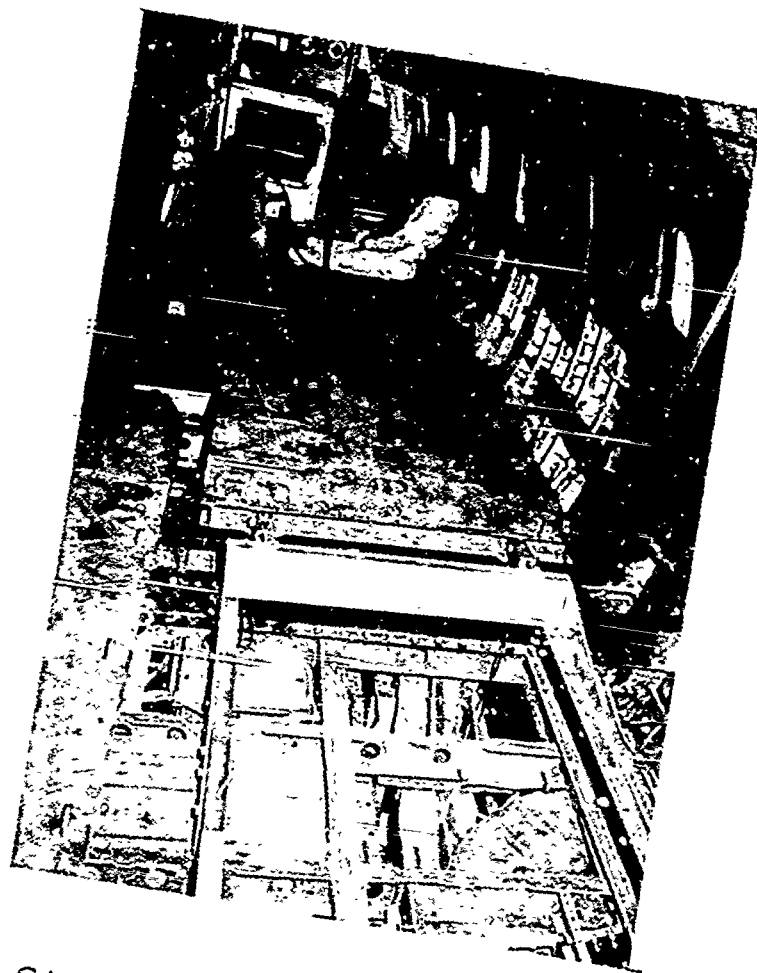
The aft seat shown in Figure 69 was released from the floor track due to the locks not being in place on either side of the seat. The seat stayed in its original location but rotated 90 degrees aft and came to rest lying on its back. Both occupants, the dummy and the child doll, remained well positioned and in place in the seats and the restraint systems were undamaged. The child restraint harness still supplied restraint but the diagonal shoulder harness and lap belt restraint on the outboard dummy was ineffective in this position because of slack in the shoulder strap. Longitudinal and vertical accelerations were recorded from the pelvic region of the 95th percentile dummy passenger of this seat. These accelerations are shown in Appendix II.

FIG. 69 VIEW SHOWING 90-  
DEGREE ROTATION  
OF AFT CONSTEL-  
LATION SEAT AND  
OCCUPANTS

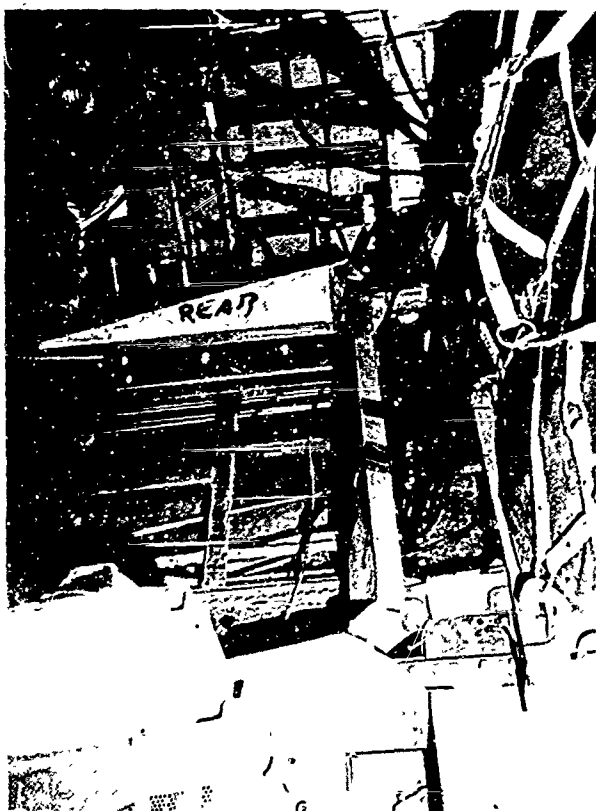
Following the test the fuselage section containing the cargo experiment was generally intact even though floor accelerations of approximately 20G's vertical, 10 - 20G's longitudinal, and 5 - 10G's lateral were experienced. Figure 76 shows the external fuselage area surrounding the experiments.

FIG. 76 FUSELAGE SECTION THAT HOUSED CARGO EXPERIMENT

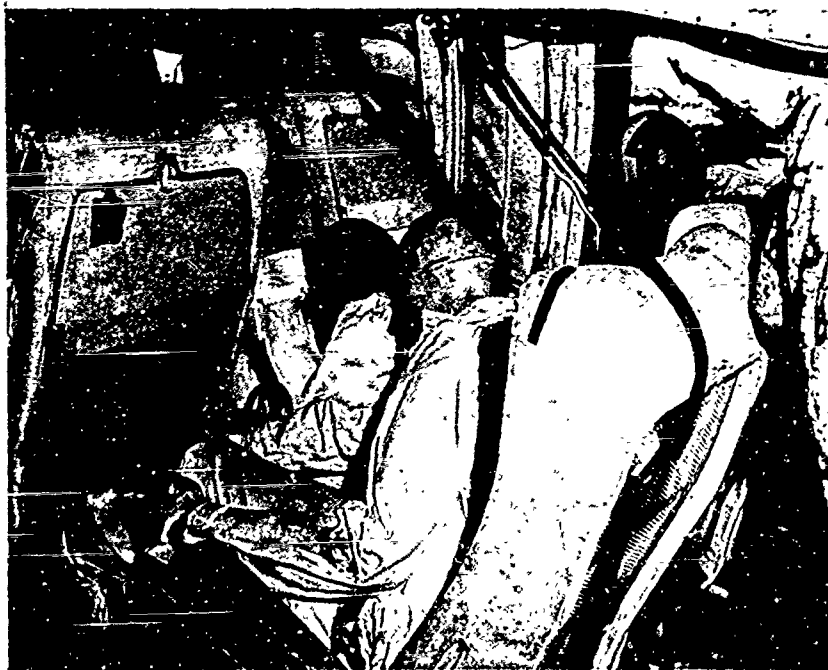
FIG. 81 POSTCRASH POSITION OF FORWARD FACING SEAT DUMMIES

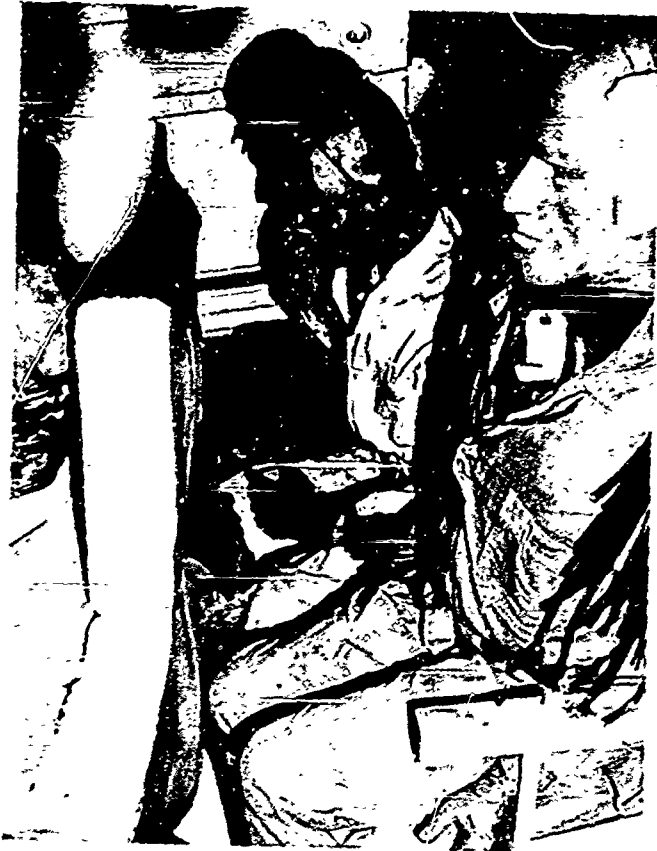
FIG. 84 POSITION OF  
OCCUPANTS OF  
THREE PASS-  
enger REAR  
FACING SEAT,  
POSTCRASH

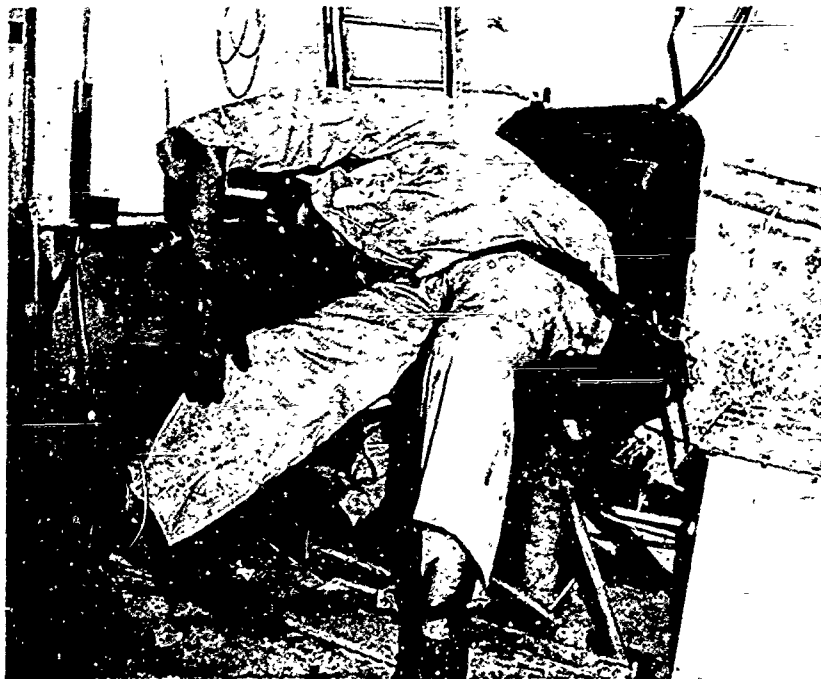
The side facing seat remained attached to the aircraft floor and sustained no gross structural failure. The lap belt remained attached, but this minimal restraint allowed the dummy's head and shoulders to move forward (laterally) so that the dummy's head struck the galley partition, 24 inches forward of the seat as shown in Figure 93. The dummy moved forward (with respect to the aircraft) on the seat 6 inches, remaining only partially on the seat pan. The right leg of the dummy swung around toward the dummy's right (forward in the airplane) about 35 degrees. Vertical loading caused slight downward bending of the forward edge of the tubular seat pan frame as shown in Figure 94. This was the only permanent deformation of the structure of this seat. The lap belt load, developed in the side facing seat reached a maximum of approximately 1200 pounds (one side). This is consistent with the lap belt loads developed in forward facing seats.

FIG. 93 SIDE FACING SEAT OCCUPANT, POSTCRASH  
POSITION, VIEWED FROM AISLE

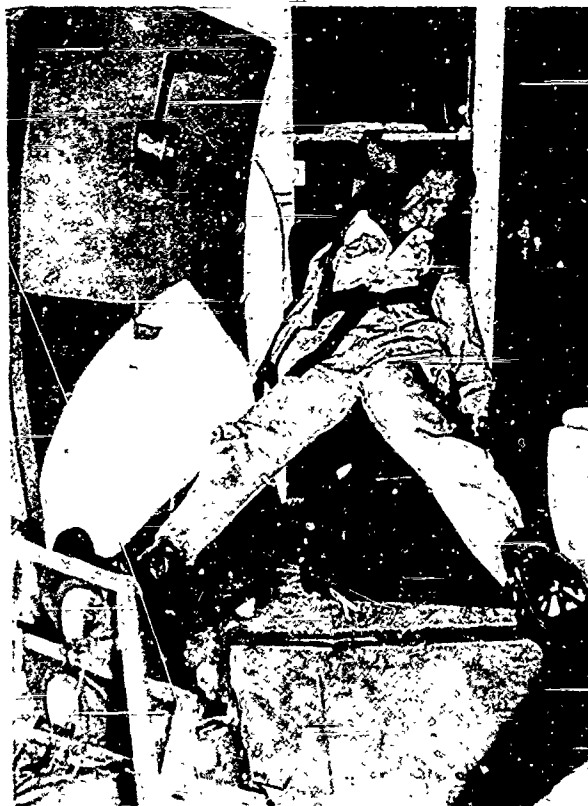
The shoulder harness and lap belt, remained intact and attached to the installation points, however, this did not prevent the occupant from submarining. The dummy submarined until the lap belt was around its chest, up to the armpit on the left side and halfway up the rib cage on the right. The legs were sprawled outward and forward, and the dummy's head was impaled on the upper right corner of the seat back. (See Figure 101). The rubber skin of the dummy's head was torn extensively, and the skin separated completely from around the neck. The attachment of the seat back to the center partition failed, and the bar that acted as a brace for the aft part of the seat was found to be forward of the center lavatory partition to which it normally attaches. The right front seat leg was buckled inward at the floor approximately three inches from its normal position as shown in Figure 102.

FIG. 101 OVERALL POSTCRASH  
VIEW OF STEWARDESS  
SEAT EXPERIMENT

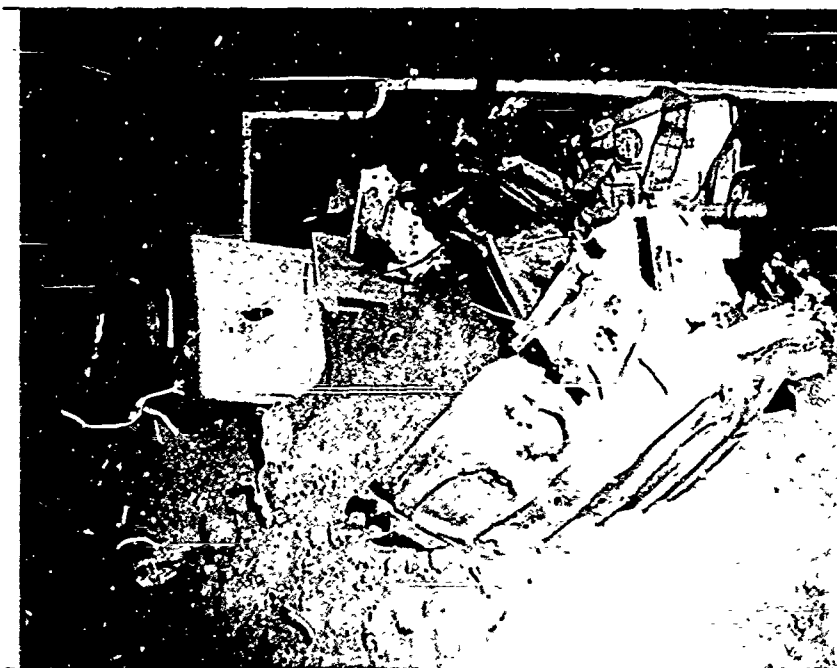
A post crash view of the radioactive materials shipping containers is presented in Figure 110. Even though the cargo compartment volume was reduced by approximately 50 percent, the actual damage occurring to the cargo appeared to be small. CARI personnel removed the containers for further evaluation.

FIG. 110 POSTCRASH VIEW OF RADIOACTIVE SHIPPING  
CONTAINERS IN FORWARD CARGO COMPARTMENT
